Manhole Inspection Summary

Manhole # S41I__052MH

Insp Date: **5/14/08 9:36 AM**

Location Address: **side of 1400 eastern ave**

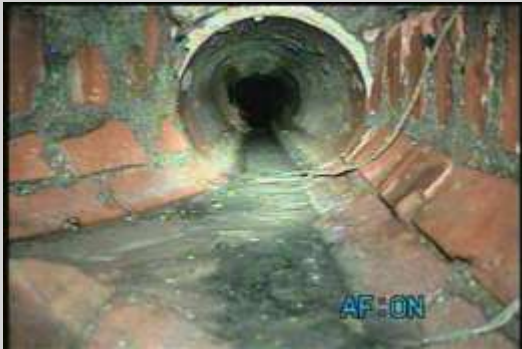
12 O'Clock Outflow

8 in. Circular Gravity Sewer
Pipe Out @ 12 O'Clock

Pipe Material: **Clay** ☐ Pipe Lined

Invert Depth: **9.75** (ft.) Flow Characteristics: **Fast**

Deposits: ☒ None ☐ Mud ☐ Sludge ☐ Debris ☐ Grease

Infiltration: **None** Pipe Seal Cond: **Unknown**

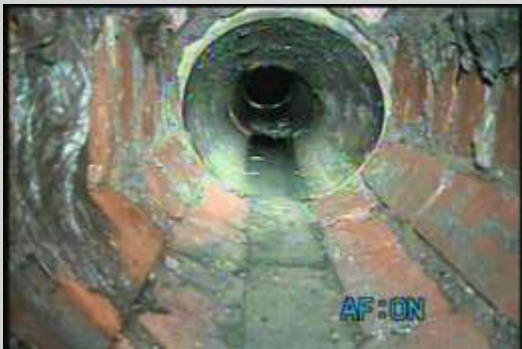
6 O'Clock Inflow

8 in. Circular Gravity Sewer
Pipe In @ 6 O'Clock

Pipe Material: **Clay** ☐ Pipe Lined

Invert Depth: **9.68** (ft.) Flow Characteristics: **Fast**

Deposits: ☒ None ☐ Mud ☐ Sludge ☐ Debris ☐ Grease

Infiltration: **None** Pipe Seal Cond: **Unknown**

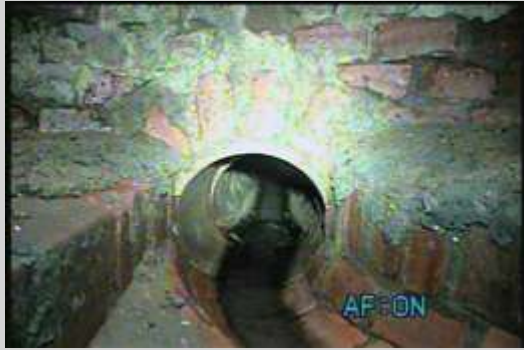
9 O'Clock Inflow

8 in. Circular Gravity Sewer

Pipe In @ 9 O'Clock

Pipe Material: **Clay** ☐ Pipe Lined

Infiltration: **None** Pipe Seal Cond: **Unknown**
